Journal of Periodontology & Implant Dentistry

Case Report

A Sinus Tract Following Prosthodontic Treatment with a Dental Implant: A Case Report

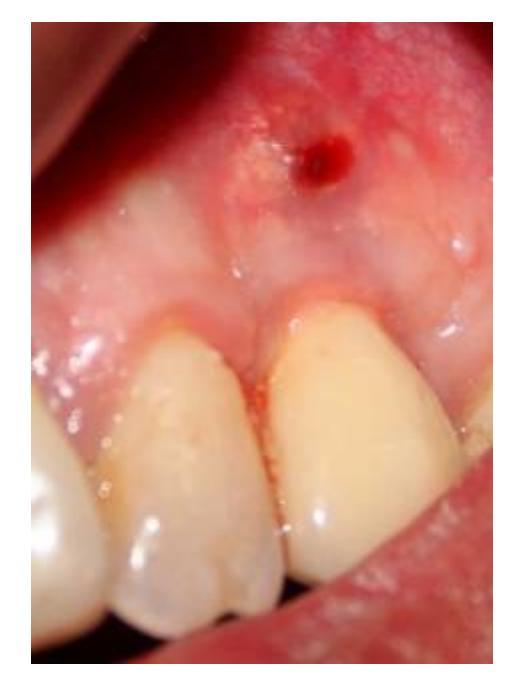
Figure 1. Clinical view showing the sinus tract.

A 26-year-old male with a non-contributory medical history was referred due to constant pain (for about two weeks) in the gingiva of maxillary left canine which was replaced by a single implant-supported prosthesis (ITI; Straumann, Waldenburg, Switzerland) about four years previously. The implant was 3.5 mm in diameter and 14 mm in length, supporting a cemented single crown. The impression technique used for the patient was closed tray implant level technique using condensation silicone impression material (Speedex, Coltène Whaledent, USA) without placing a gingival retraction cord. The patient had not attended regular annual visits. The time span between completion of the prosthodontics treatment and the last visit was 4 years. Clinical examination revealed a sinus tract in the buccal gingiva of left canine corresponding to the location of pain. The gingiva of the left canine was slightly red compared to the adjacent pink gingiva (Figure 1). There was no sign of plaque-induced gingivitis or periodontal pocket. The radiograph showed no unusual bone loss related to the implant or adjacent teeth (Figure 2). Under local anesthesia with 2% lidocaine containing 1:200000 epinephrine (Xylocaine Viscous, Darou Pakhsh Co., Iran), the sinus tract was incised with a scalpel blade and small fragments of condensation silicone impression material and blood were expelled (Figure 3). The lesion healed after 10 days.

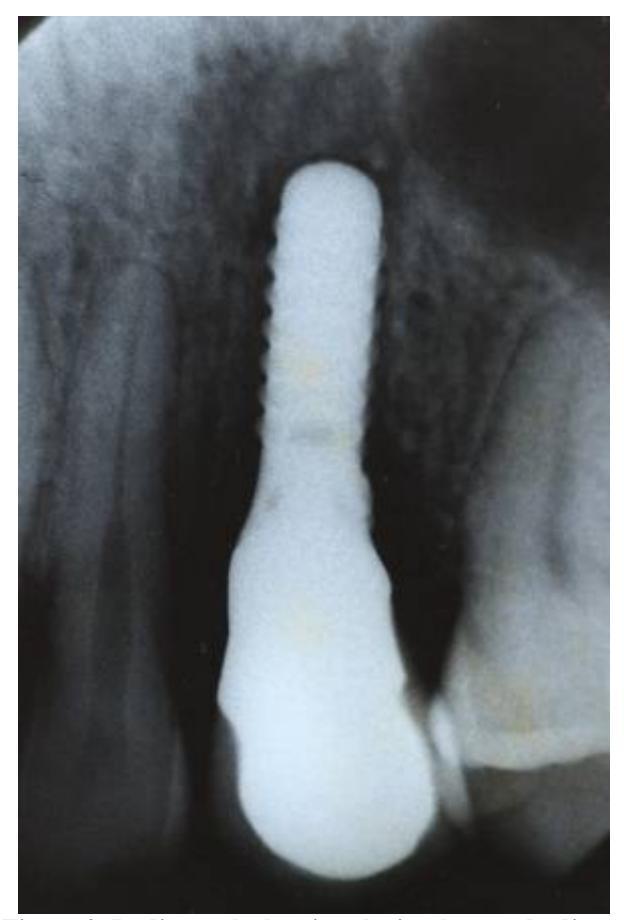
Figure 2. Radiograph showing the implant and adjacent teeth.

sound periodontal tissues and normal pocket depth and absence of pus, existence of a peri-implantitis was improbable. Since the sinus tract originated from soft tissues, there was no radiolucency related to it in the x-ray images. The gingival damage was apparently the result of insertion of some pieces of impression material during impression taking about 4 years later. There are some differences between two conventional impression techniques (closed tray and open tray) used for implant level impression taking of implants. Since impression copings remain in the impression material after removal of open tray technique, the need for accurate repositioning of them back into the impression would be eliminated.^{2,3} However, blind attachment of impression coping to the implant replicas in the impression is a disadvantage of this technique.^{4,5} Nevertheless, it has been suggested that open tray technique be used for situations with multiple implants, especially with unfavorable angulations.^{2,3} On the other hand, closed tray technique is a simpler method recommended for posterior regions of the mouth or when there is limited inter-arch space or tendency to gag.^{4,5} In this case the impression technique was closed tray impression technique which seems suitable for a single implant. It appears there is no relation between these impression techniques and remaining of the impression material in the tissue. However, other factors such as exerting excessive pressure during impression procedure or presence of thin periodontium around the implant or combination of both might

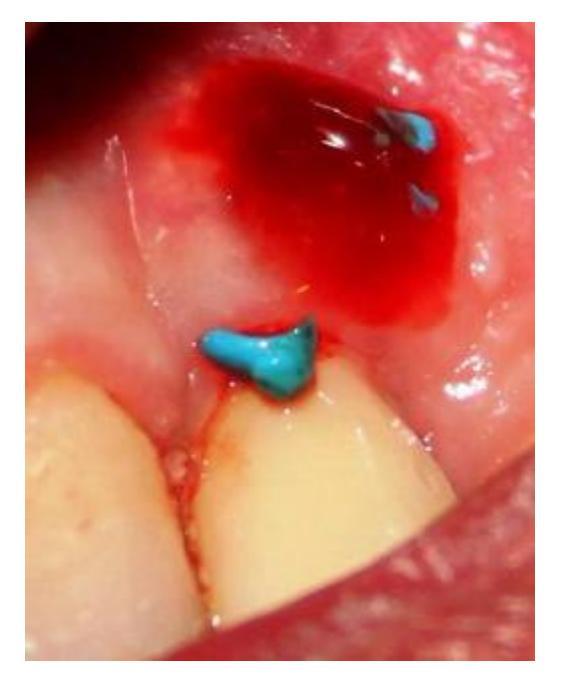
Figure 3. Clinical view showing the piece of impression material expelled after incision.
